Name Of Dam: BEAVER CREEK DAM

Location: MARTINSVILLE, VIRGINIA

PHASE I INSPECTION REPORT

NATIONAL DAM SAFETY PROGRAM

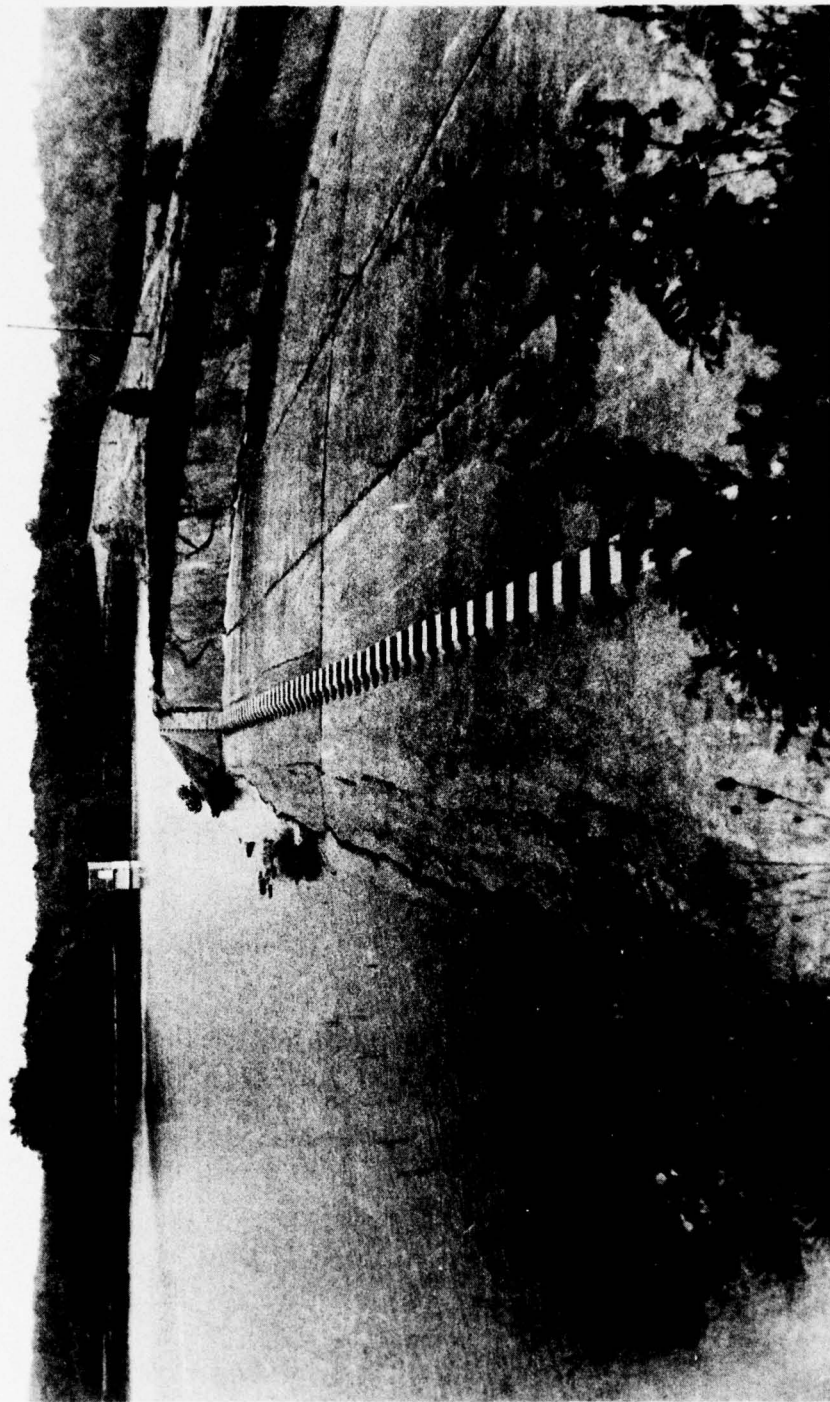
OVERVIEW OF EMBANKMENT AND SPILLWAY ENTRANCE - BEAVER CREEK DAM

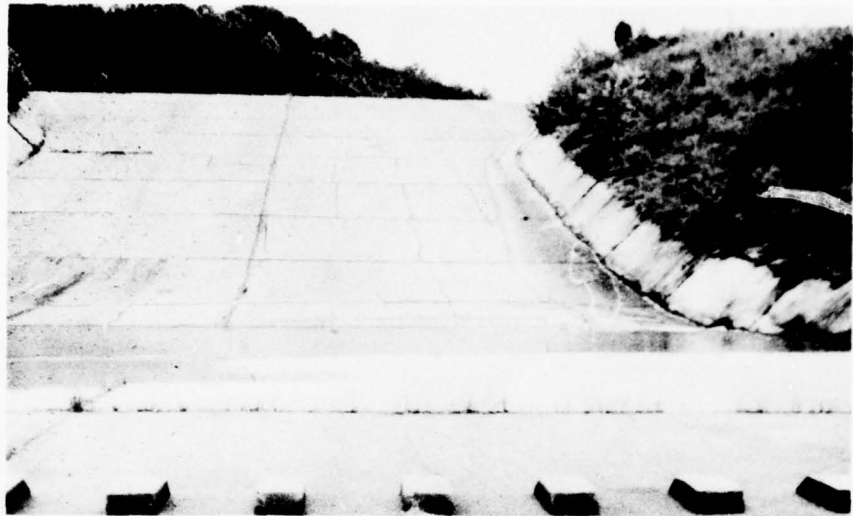
BEAVER CREEK DAM - SPILLWAY CHUTE

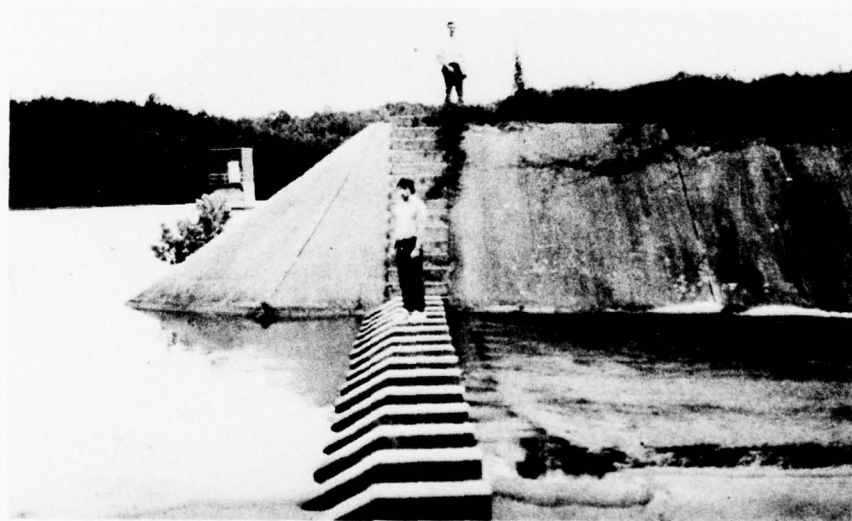
The spillway appeared to be in good condition. There were no cracks in the concrete and the construction joints had recently been sealed with a bituminous material.

BEAVER CREEK DAM - SPILLWAY CREST

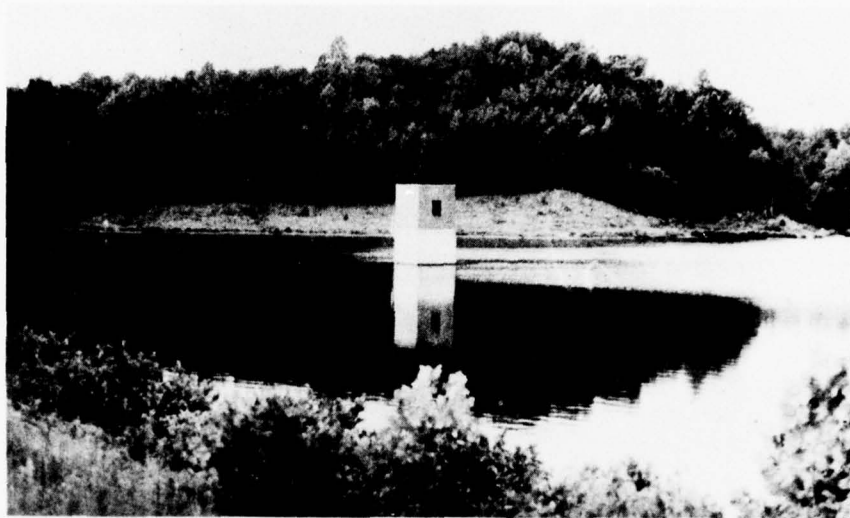
BEAVER CREEK DAM GATE TOWER

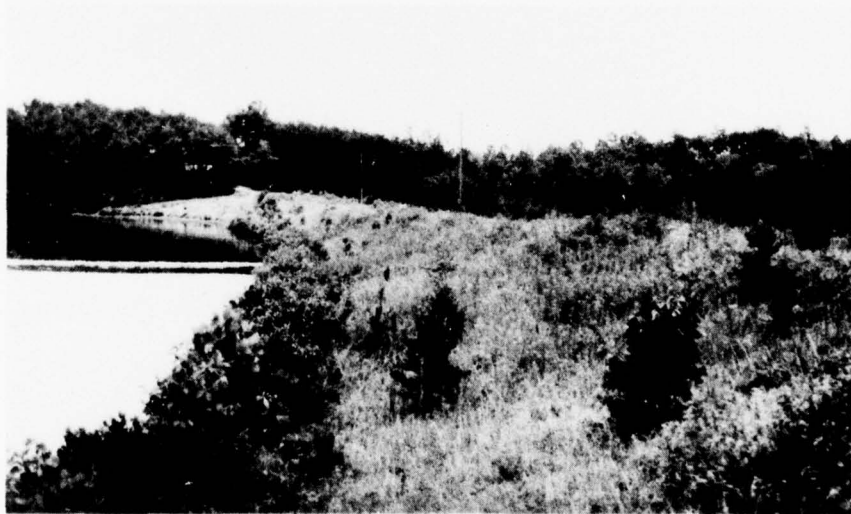
UPSTREAM SLOPE OF THE EMBANKMENT FROM THE RIGHT ABUTMENT

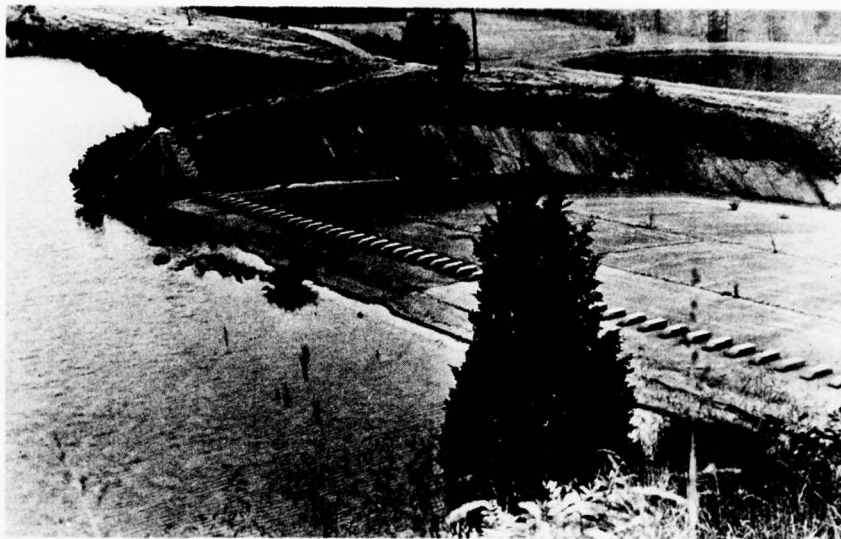
VIEW OF EMBANKMENT AND SPILLWAY FROM RIGHT ABUTMENT

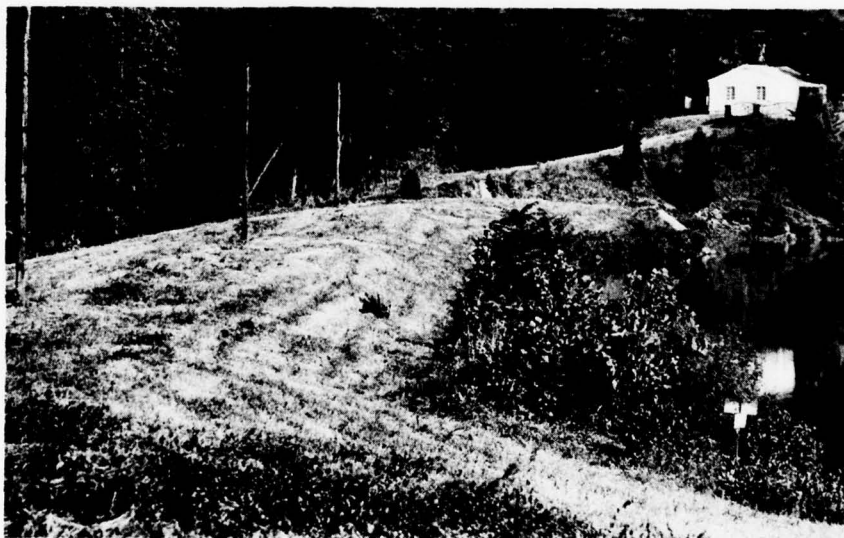
UPSTREAM FACE OF EMBANKMENT FROM LEFT ABUTMENT
